Introduction and methodology (Freiha pottery report)

Qatar Islamic Archaeology and Heritage Project

End of Season Report

2013 - 2014

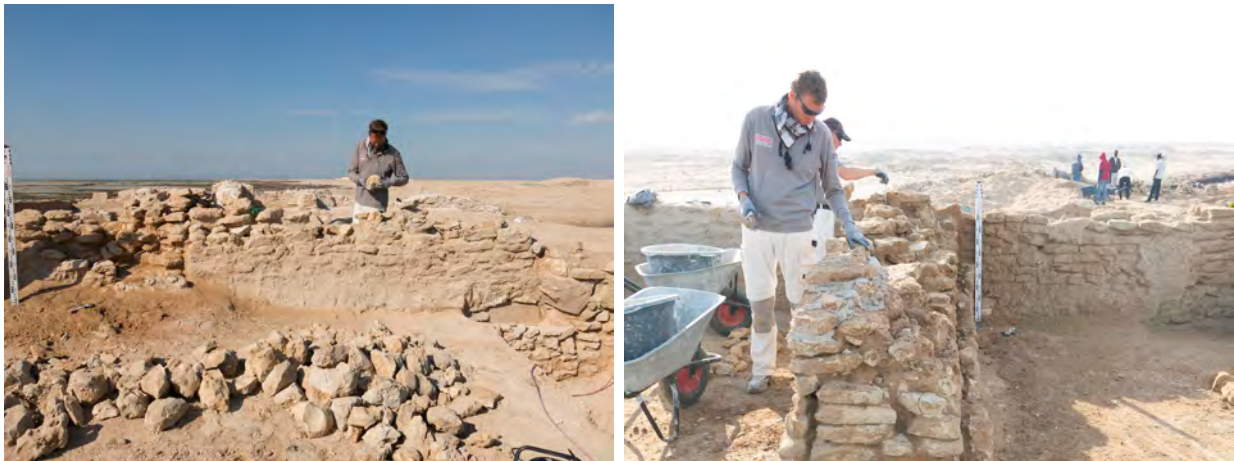
Figure 7.15: Voids in the structure and the capping were closed with dolomite stones and lime mortar. (WE-0100 & WE-0116)

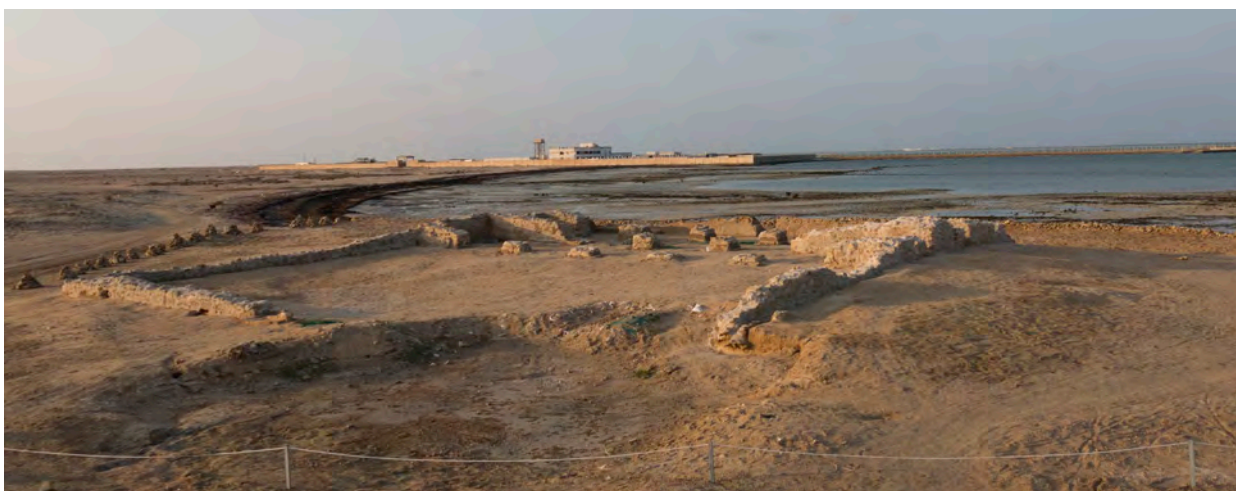
Figure 7.17: View of the mosque before restoration work, showing the robbed-out northeast corner in autumn 2013. (WE-0139)

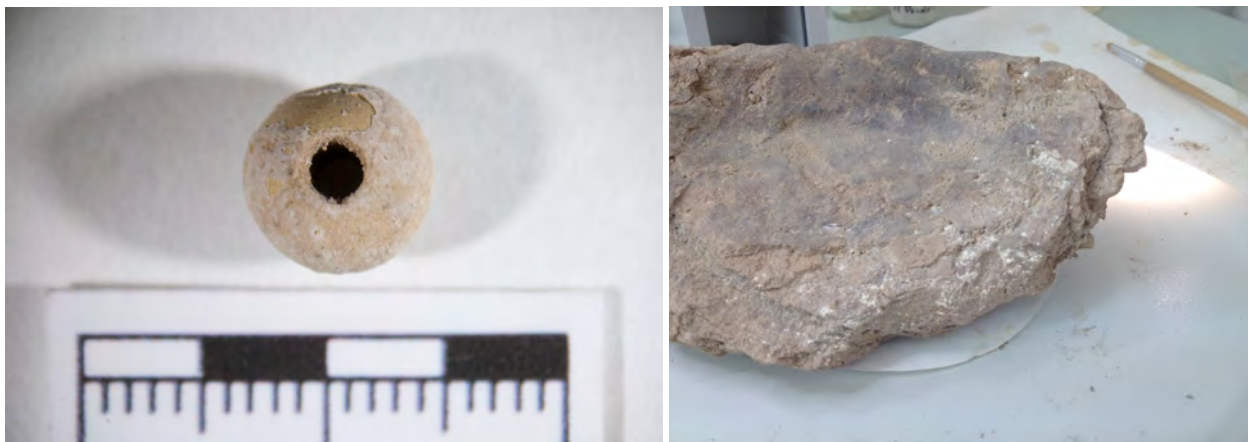
Figure 15.1: An example of visual efflorescence of salt on the exterior of a ceramic bead and a low fired ceramic fragment. (OF-3731 & UG)

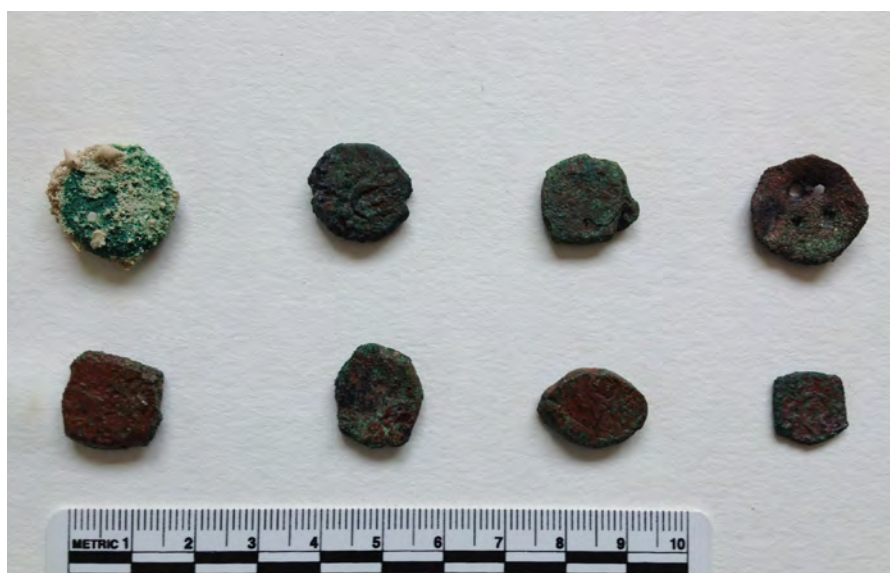
Figure 15.4: A collection of copper alloy coins, showing one untreated and seven treated by mechanical cleaning, chemical inhibition and consolidation. (OF-3311)

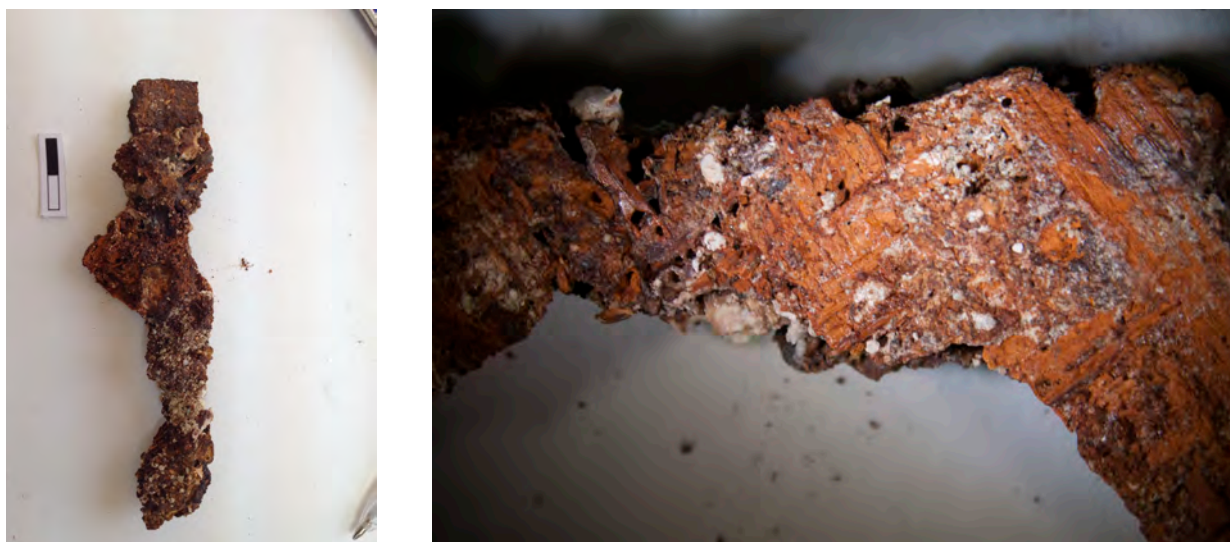
Figure 15.5: An untreated iron knife with a thick corrosion layer. Attached to the surface are residues of organic material. (UG & OF-3914)
